Appendix A. Site Decommissioning Plan

SITE DECOMMISSIONING PLAN FOR THE CALTECH SUBMILLIMETER OBSERVATORY

TMK: (3) 4-4-015:009 (por.)

FEBRUARY 24, 2021

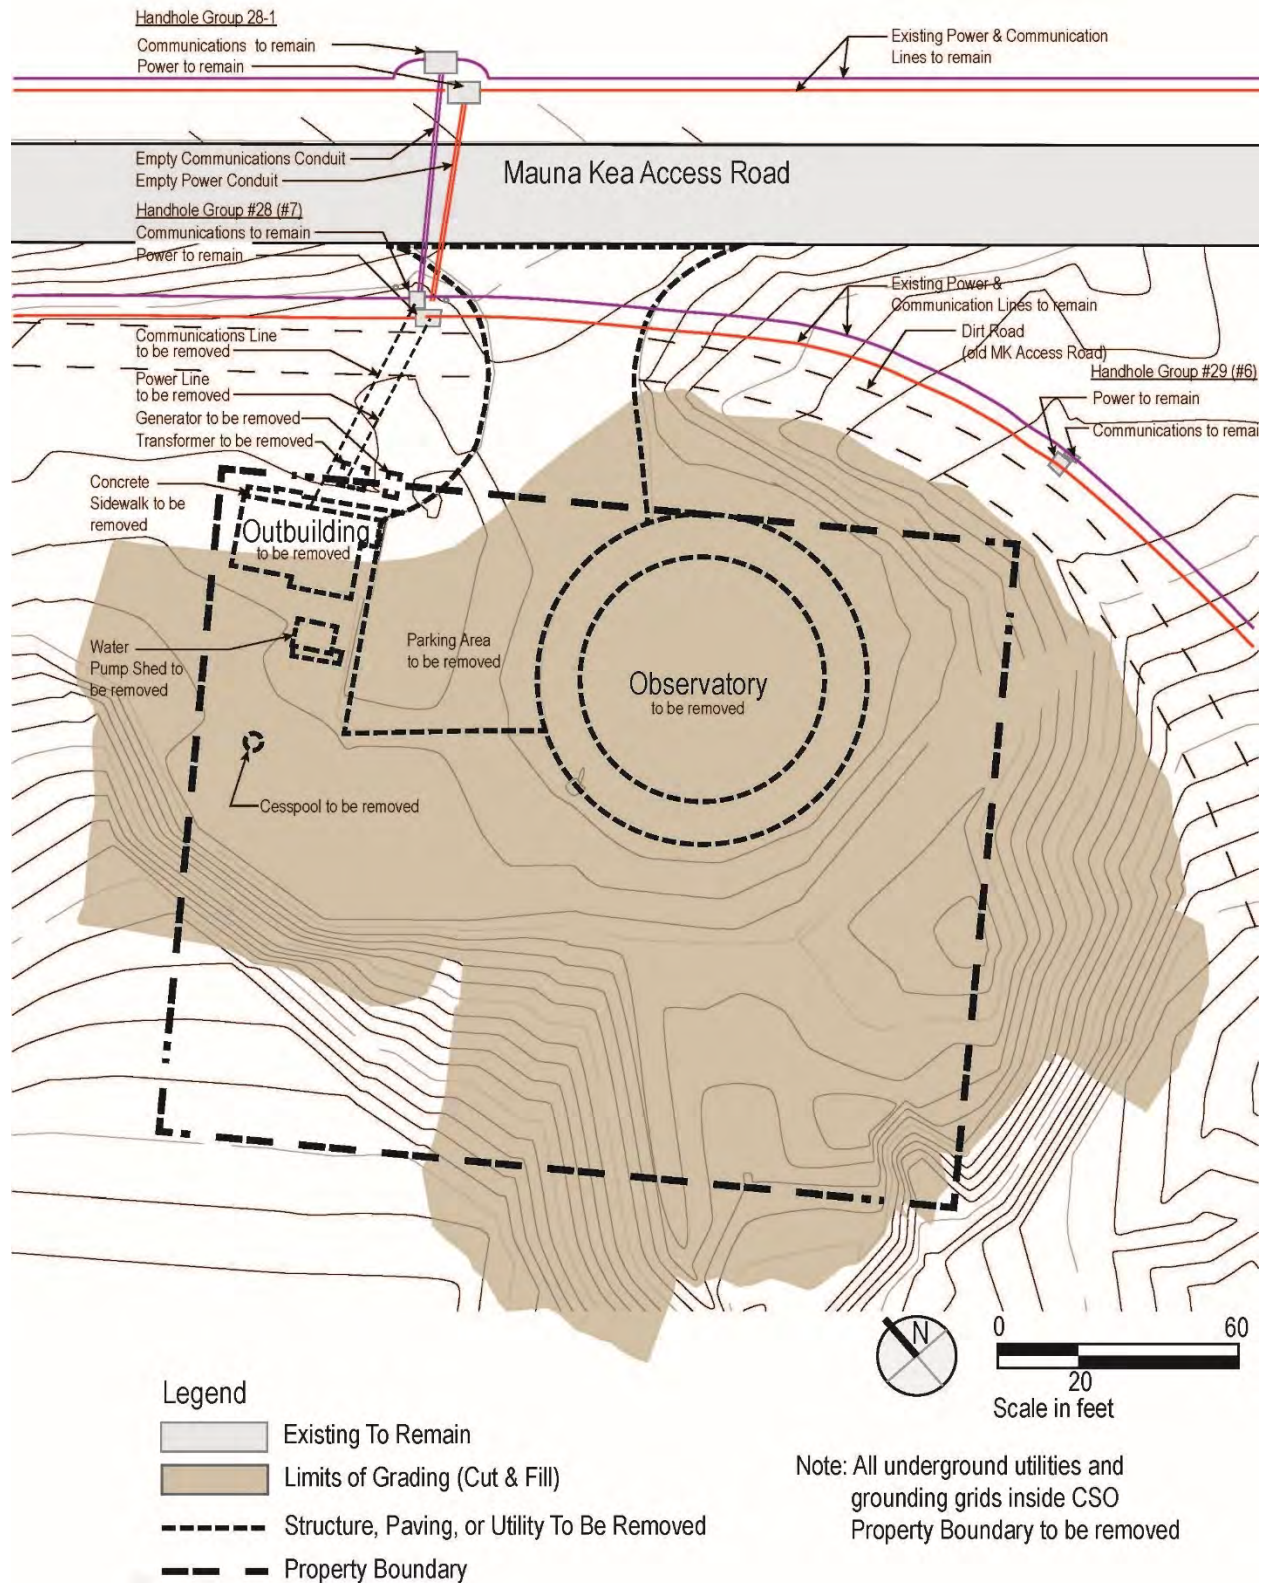
Figure 4-1: ALT-2 Scope of Work

Figure 4-1 illustrates the ALT-2 scope of work and Figure 4-2 illustrates anticipated site conditions following the implementation of the ALT-2 removal and restoration scope of work.

- The observatory and outbuilding foundations, cesspool, and other subsurface infrastructure on the CSO Site would be completely removed. The bulk of the subsurface infrastructure did not require excavation into the existing lava flow during construction. That infrastructure, and the fill around it, can be readily removed. There are locations where excavation into the lava flow took place during CSO construction, for example, the cesspool. The cesspool and other infrastructure, and fill around them, where excavation into the lava flow occurred, can also be readily removed but doing so will create cavities that will be addressed in the restoration process.

- Site restoration, as follows, using the methods outlined in Chapter 6, the SRP:
 - The topography would be returned to its pre-construction condition to the greatest extent possible. This will be achieved by removing fill placed on the lava flow during construction to the greatest extent possible. Cavities in the lava flow, where excavation occurred during construction (e.g., the cesspool), will be filled with a portion of the fill placed on the lava flow during construction, which is native to Maunakea.

- The habitat would be restored to accommodate arthropod fauna to the greatest extent possible. In areas where cavities in the lava flow have been filled, rocks will be piled instead of attempting to recreate the flow. This would return the entire site to a condition consistent with the surrounding environment.
- Biological monitoring to characterize the effectiveness of restoration efforts as discussed in Chapter 6, the SRP.

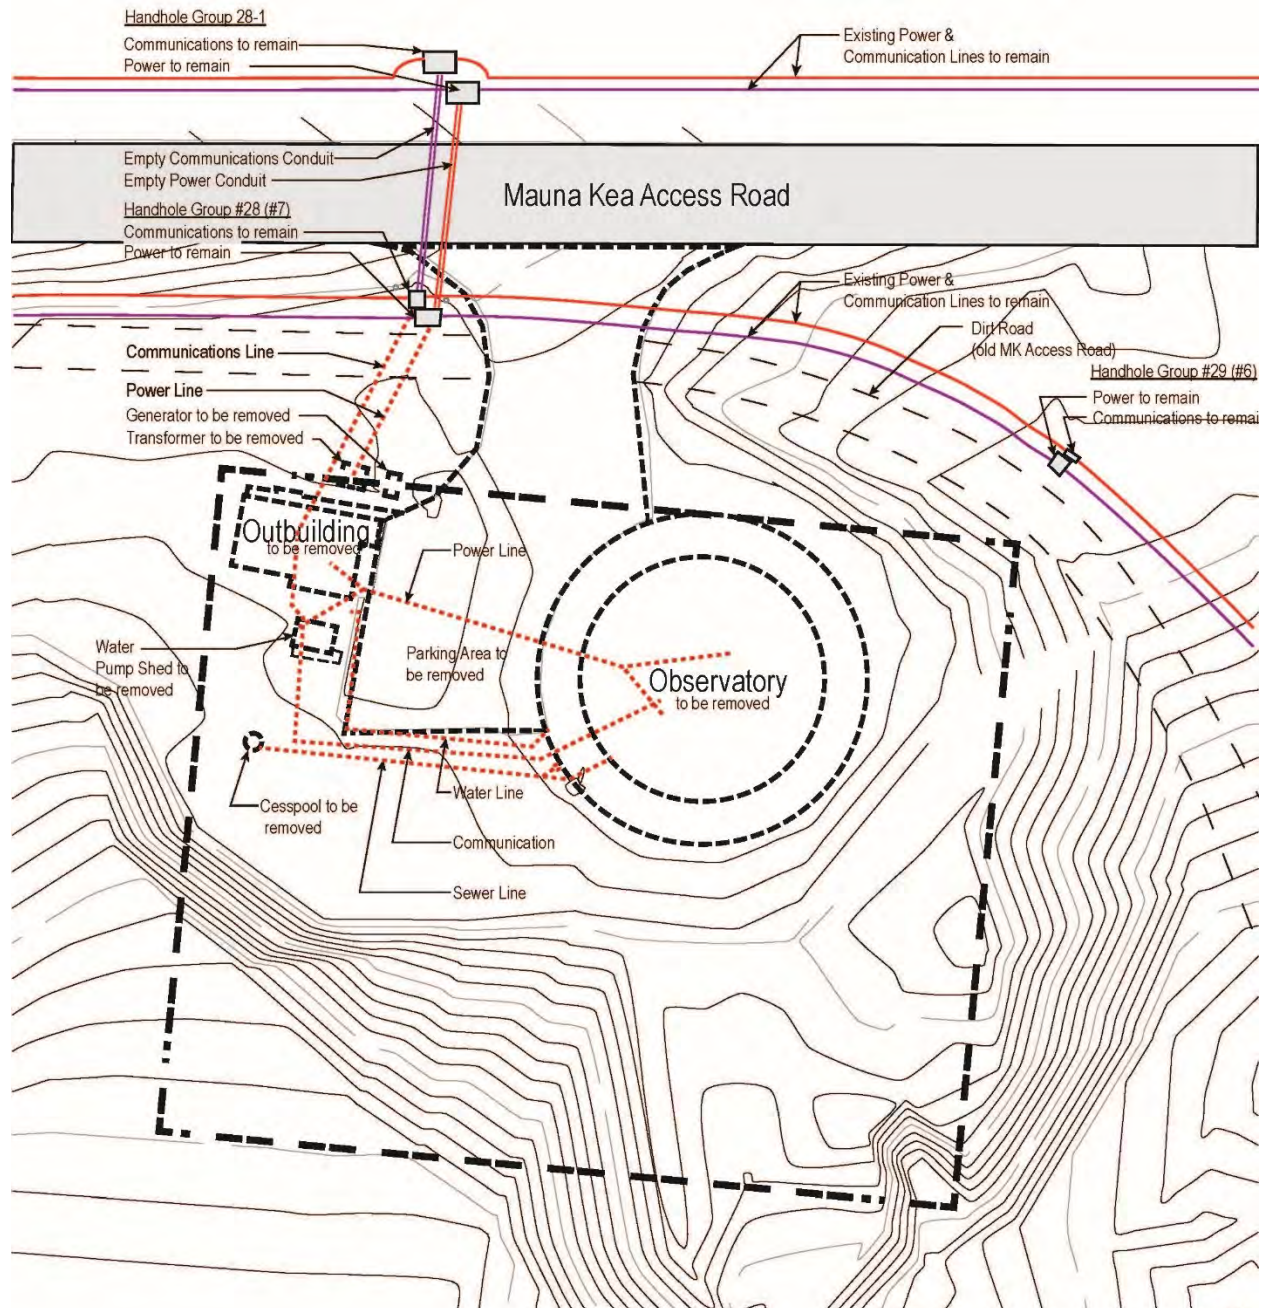
Figure 4-5: ALT-4 Scope of Work Example

- Existing To Remain
- Property Boundary
- Structure/ Paving To Be Removed
- Utility Line Capped and Abandoned in Place

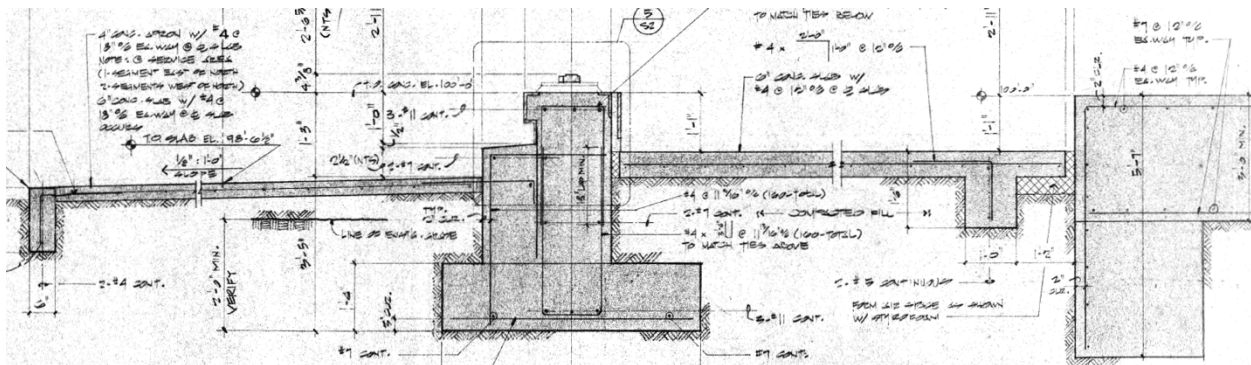
Figure 5-7: Section Drawing Illustrating a Portion of CSO's Foundation

Source: CSO Foundation Plan by H. Robert Hoggan & Associates dated 12/5/83.

The reinforced concrete foundation will be broken or cut, removed from the ground, and placed in roll-off bins. The portions of the grounding grid near the CSO's foundation will be removed during this phase; construction drawings indicate that the grounding grid is roughly one foot below grade and, therefore, all within the fill material placed on the CSO Site during construction. All material removed will be designated as deconstruction waste material and will be removed from the CSO Site and transported to an approved landfill, with the exception of recyclable material such as copper piping or grounding mats, which will be transported to a designated recycling center.

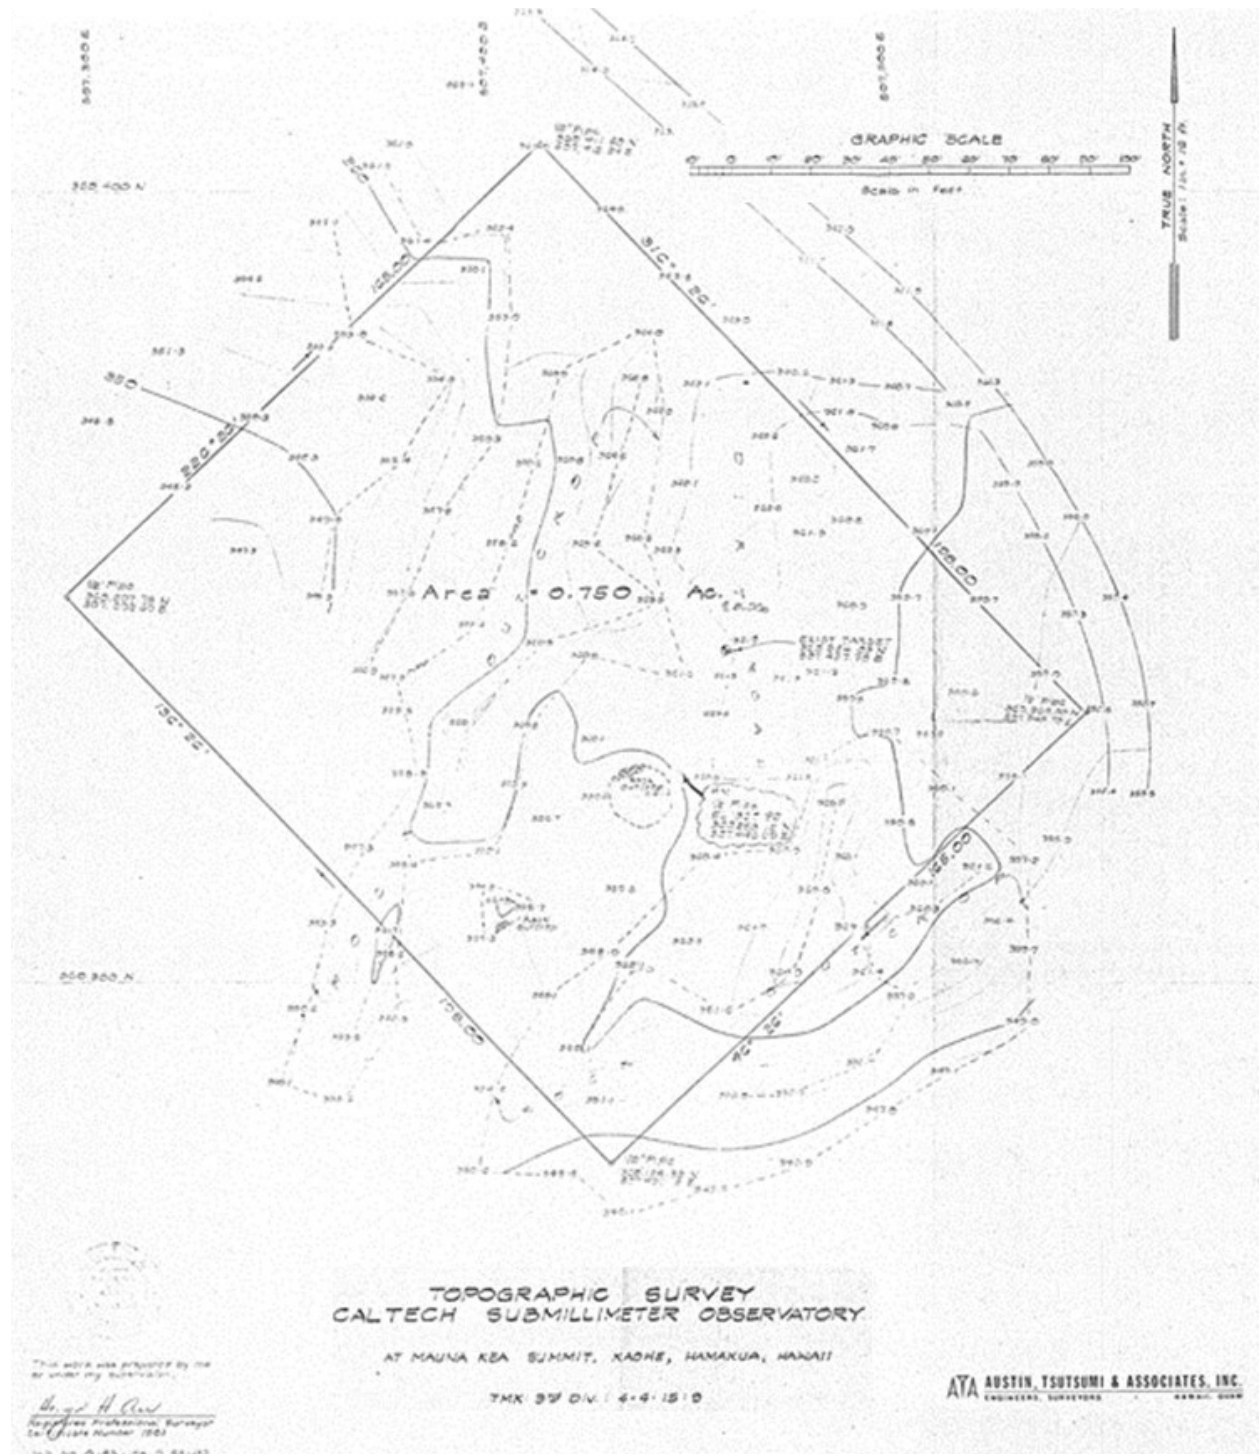
Figure 6-2: Pre-Construction Topographical Survey of Site (1982)

Source: Austin, Tsutsumi & Associates, Inc (1982)

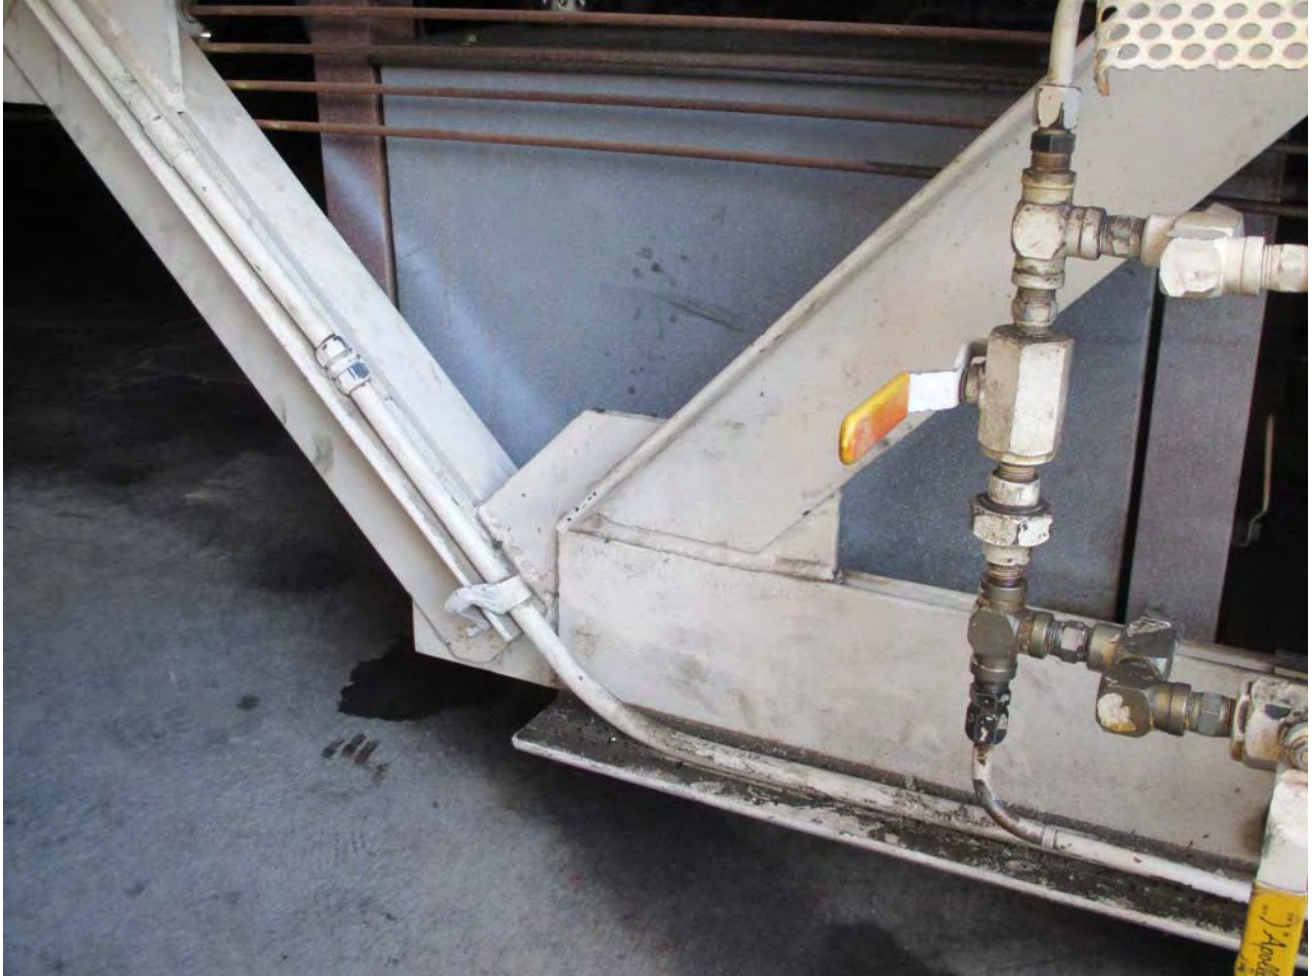
Photo 15

Minor Fluid Leak Under the First Level Platform

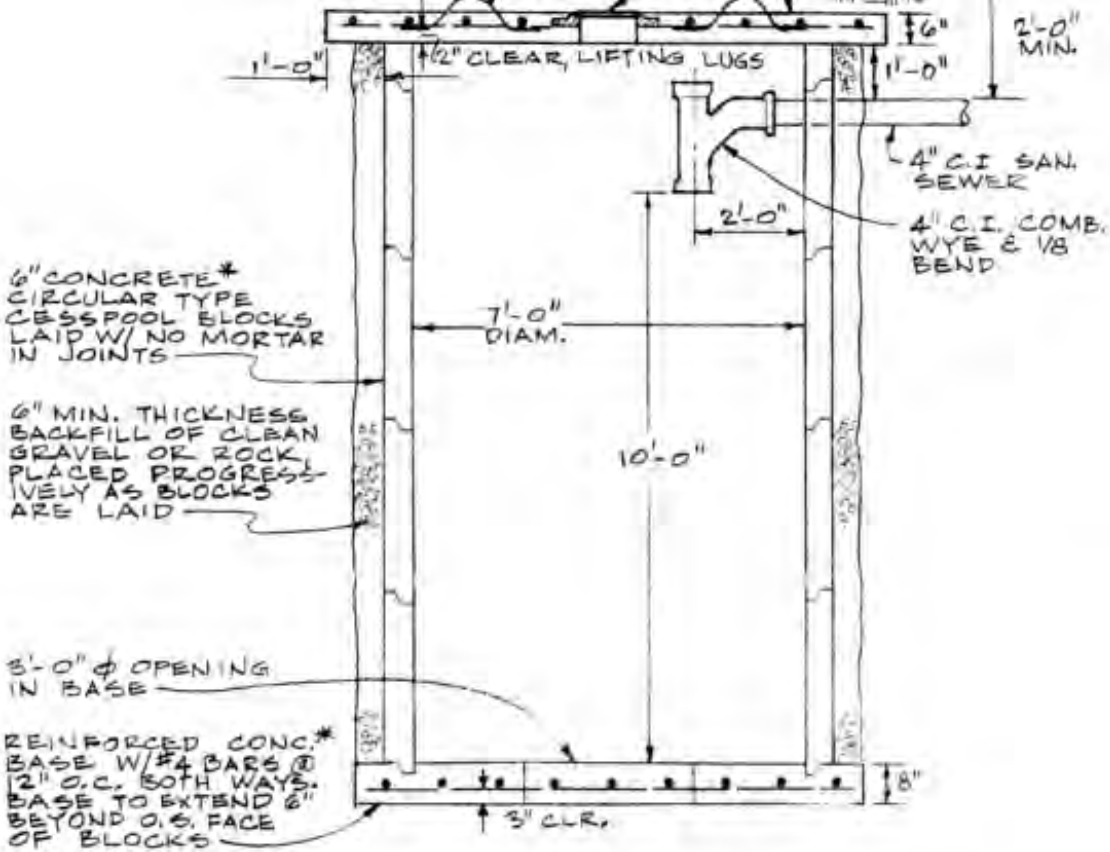
THREE (3) #4 BAR LIFTING LUGS

6" CONCRETE * CIRCULAR TYPE CESSPOOL BLOCKS LAID W/ NO MORTAR IN JOINTS

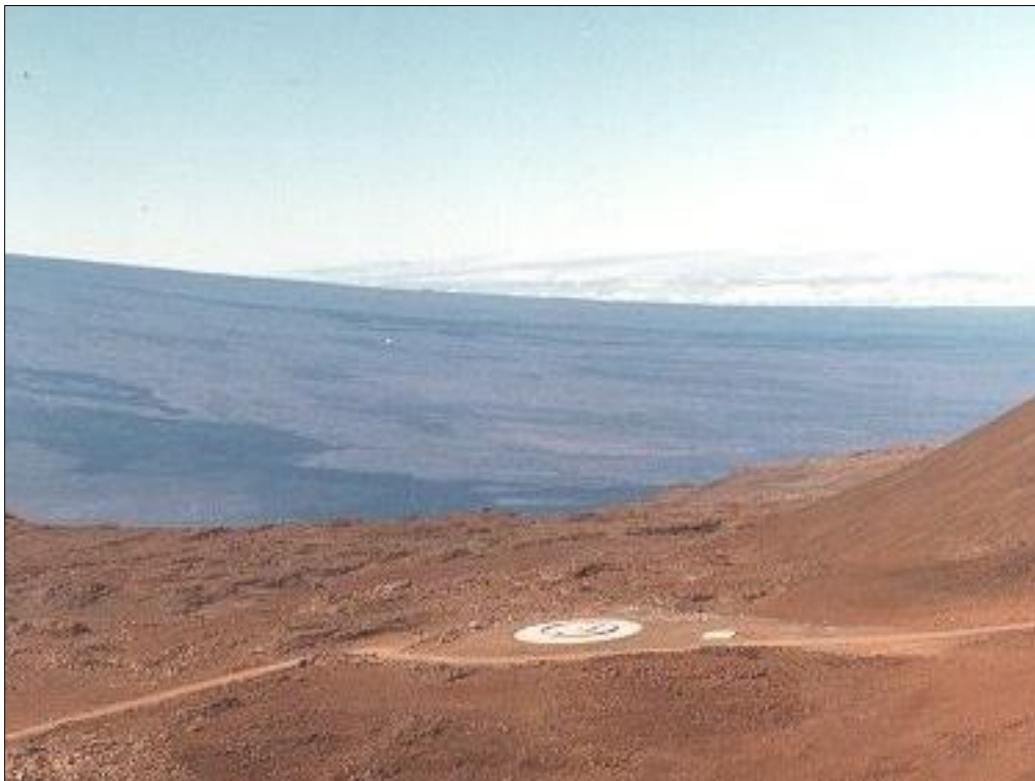
Figure 13. Observatory and outbuilding foundations in 1985, view to the southwest (Steiger 2009).

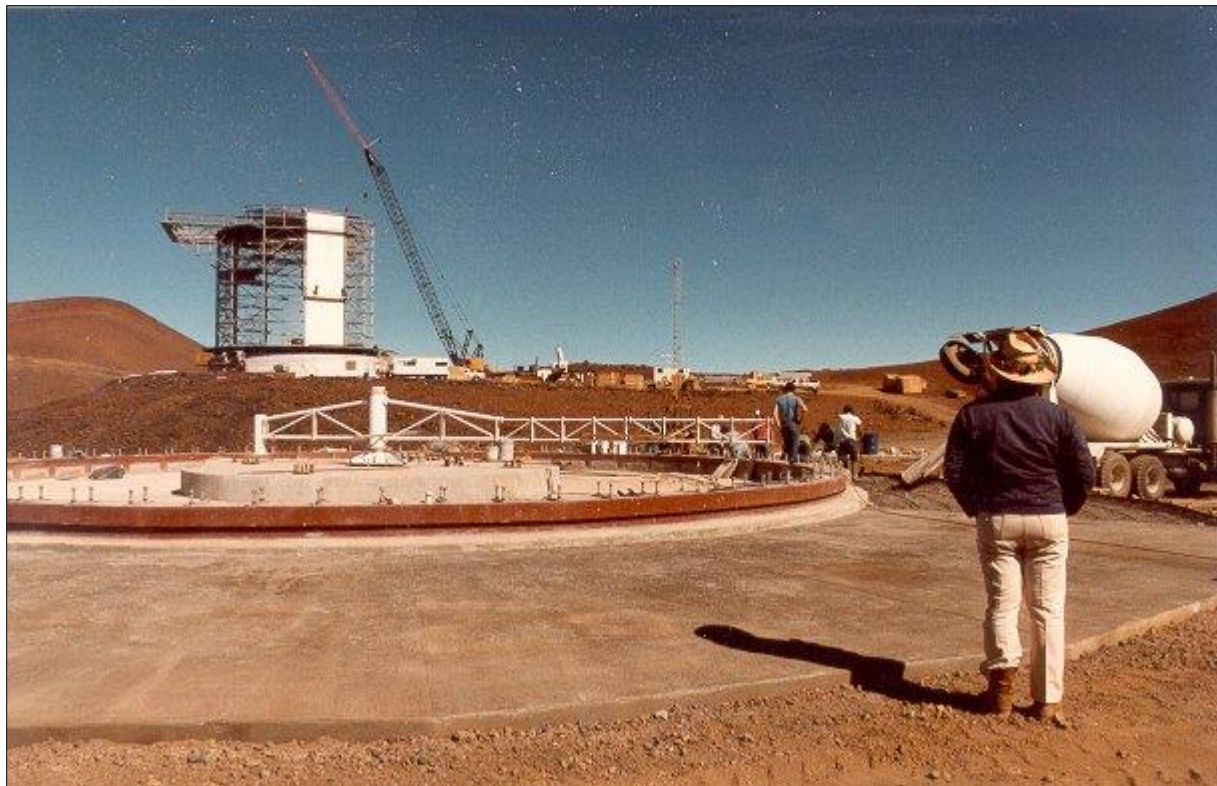
Figure 14. CSO under construction, view to the northwest (Steiger 2009).
