**FINAL ENVIRONMENTAL ASSESSMENT &
FINDING OF NO SIGNIFICANT IMPACT, CALTECH
SUBMILLIMETER OBSERVATORY
DECOMMISSIONING**

Volume 2: Appendices A, B, and C

Appendix A. Site Decommissioning Plan

SITE DECOMMISSIONING PLAN FOR THE CALTECH SUBMILLIMETER OBSERVATORY

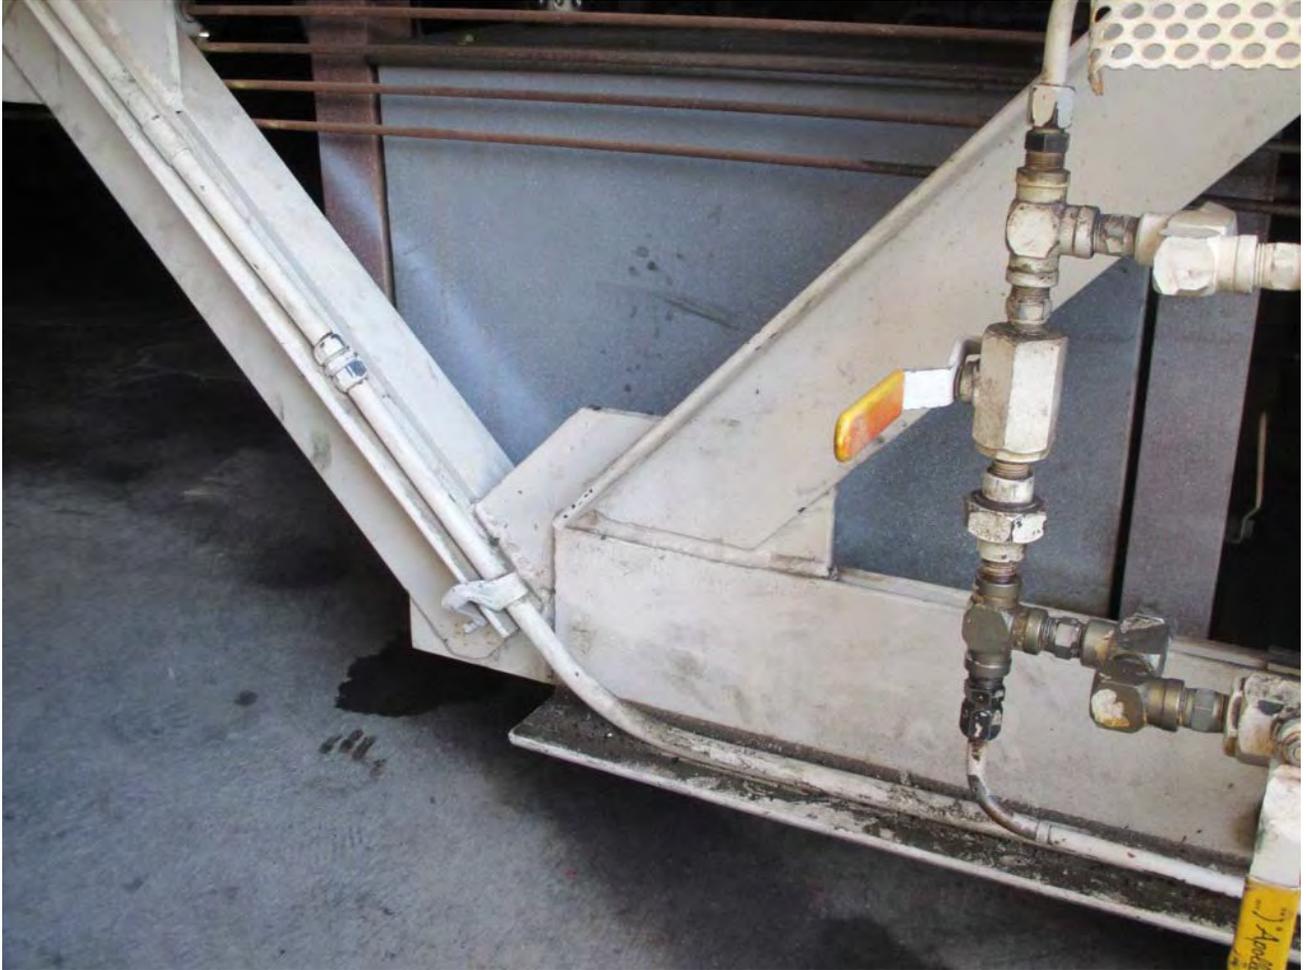
Photo 15

Minor Fluid Leak Under the First Level Platform

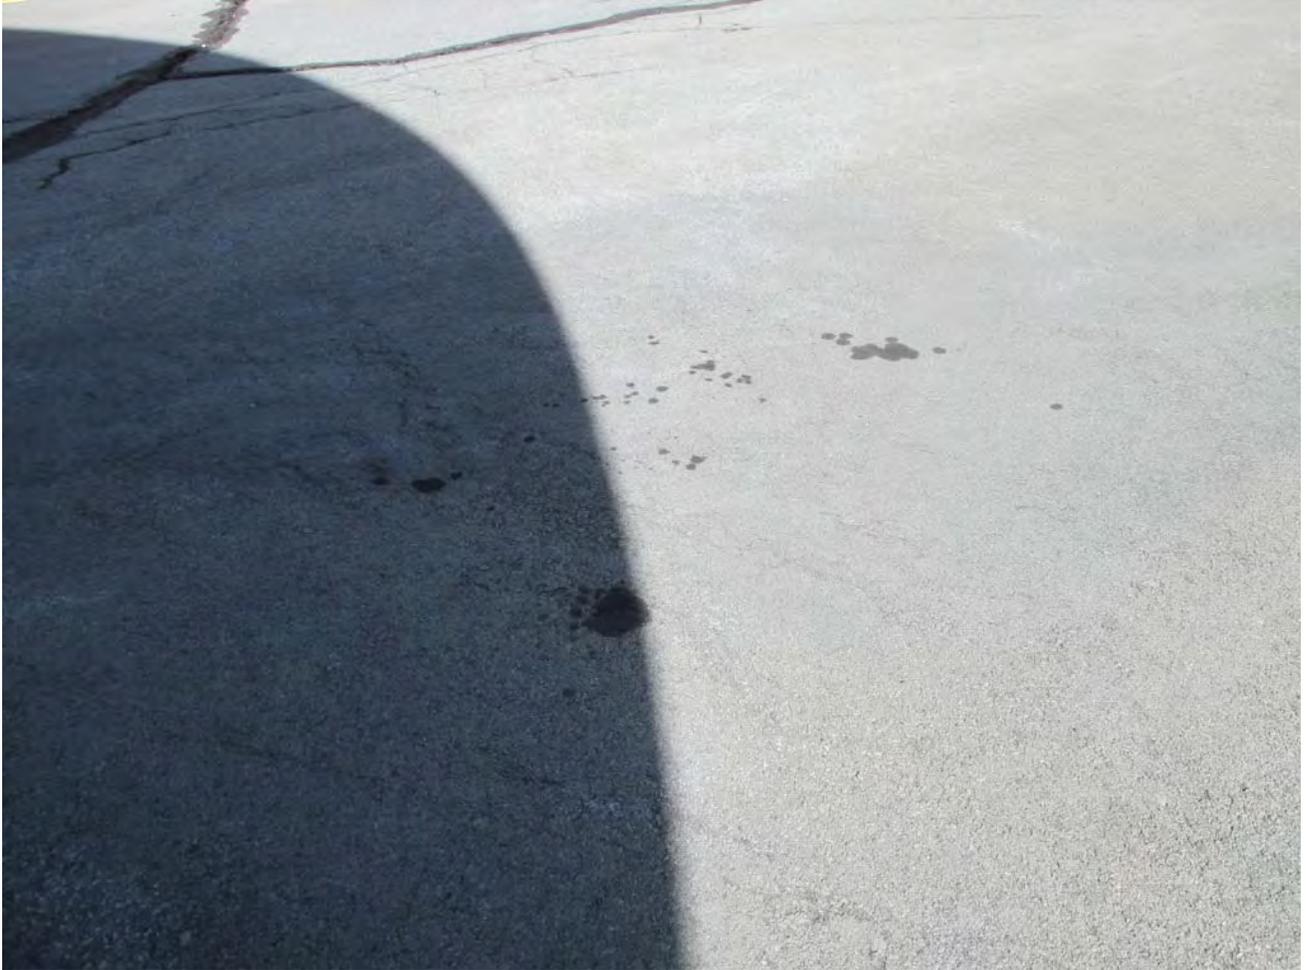
Photo 21

Staining on Asphalt of Parking Area

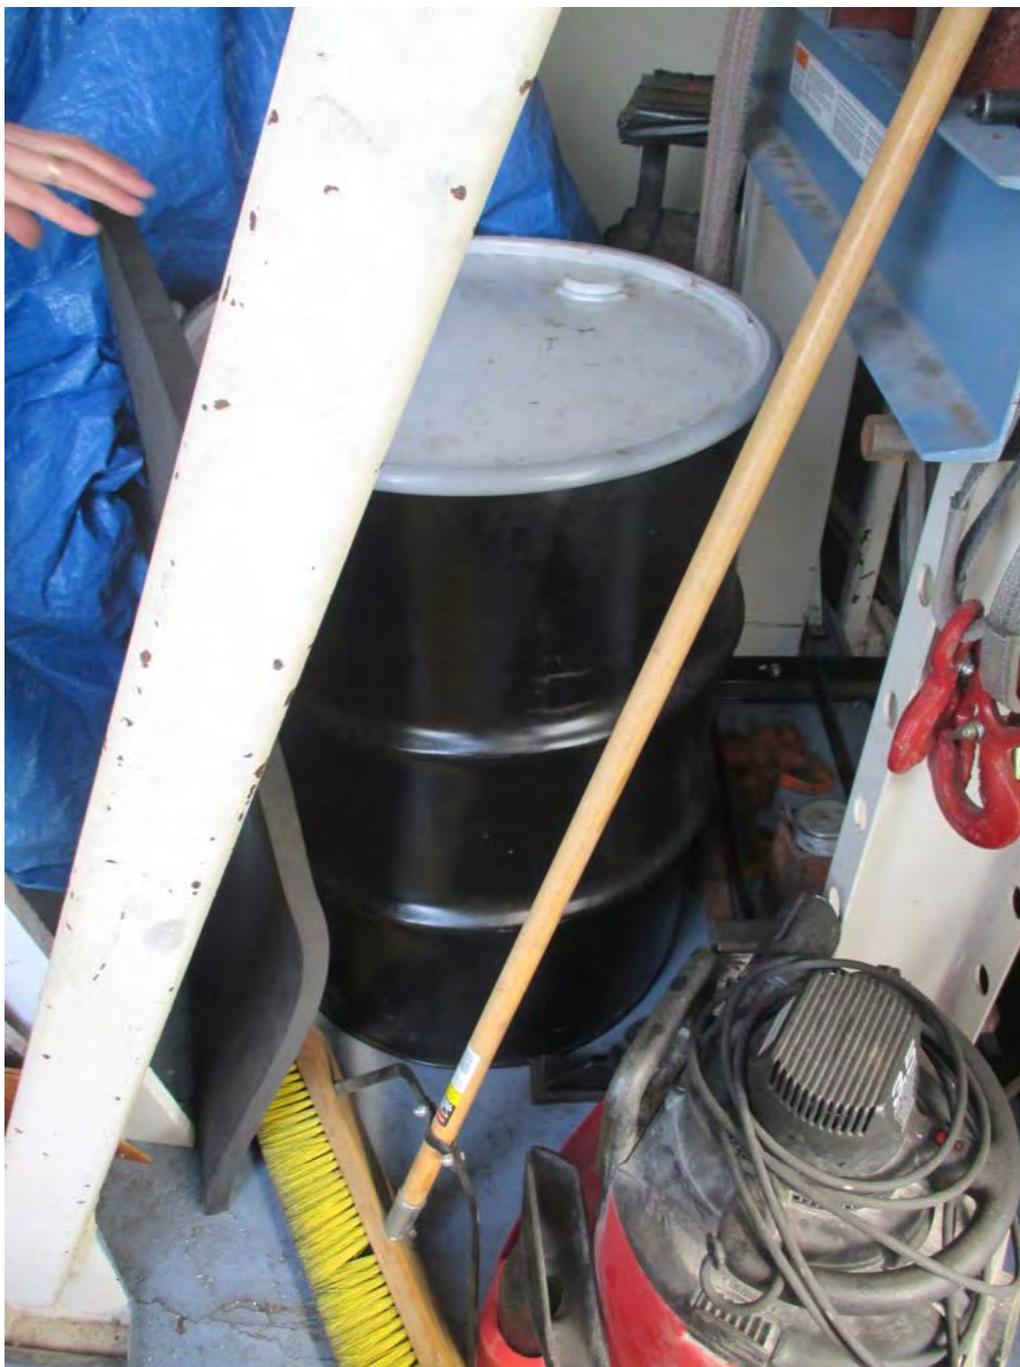
Photo 22

Unlabeled Drum on the Second Level

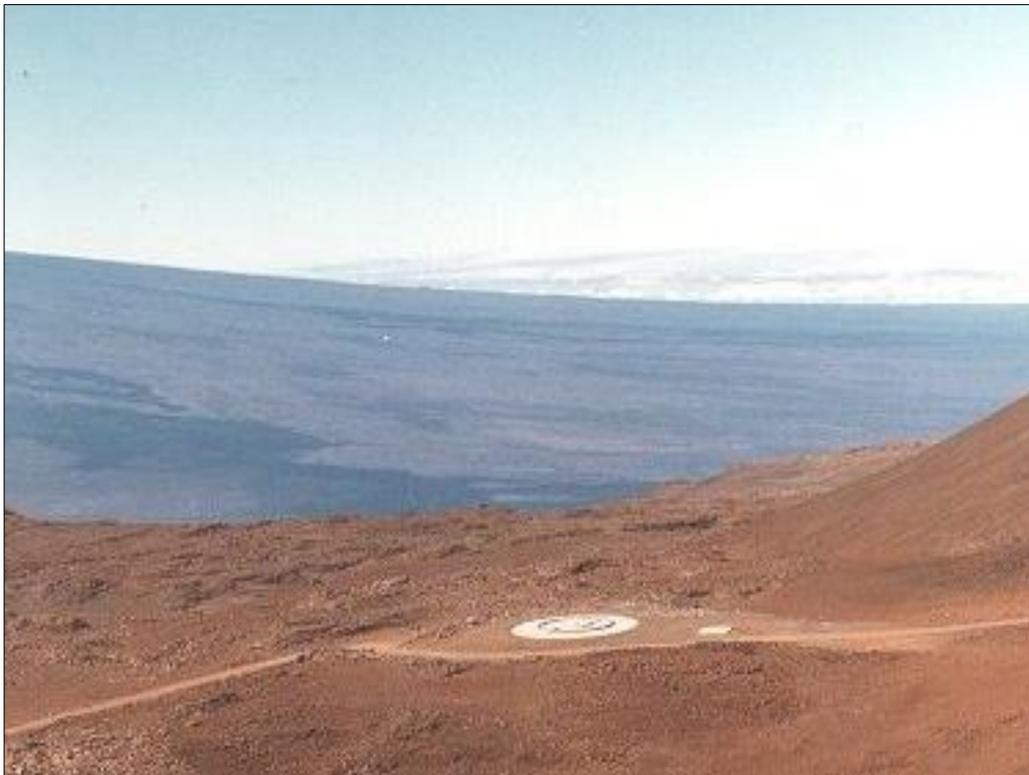
Figure 13. Observatory and outbuilding foundations in 1985, view to the southwest (Steiger 2009).

Construction of the CSO facility began in 1983 and was completed in 1987 (Steiger 2009). As designed, ground-level improvements at the CSO facility (Figures 11 and 12) included, in addition to the concrete foundation and telescope dome, a 6,000 square foot paved parking area with truck access and turnaround, and a 14 by 30 foot paved driveway. Below-ground improvements included utility trenches for conduits, auxiliary generator room and fuel tank, a large underground water tank outside the dome, a sewage holding tank under the dome, and an external cesspool (Steiger 2009). The foundation of the telescope dome (Figure 13) was installed on a graded pad located along an existing unpaved road that led to Pu'upoli'ahu and to the James Clerk Maxwell Telescope site (Figure 14). Most of the unpaved road has since been incorporated into the Mauna Kea Summit Access Road (see Figure 3), although a 150-meter-long portion of the unpaved road (see Figure 6) remains.

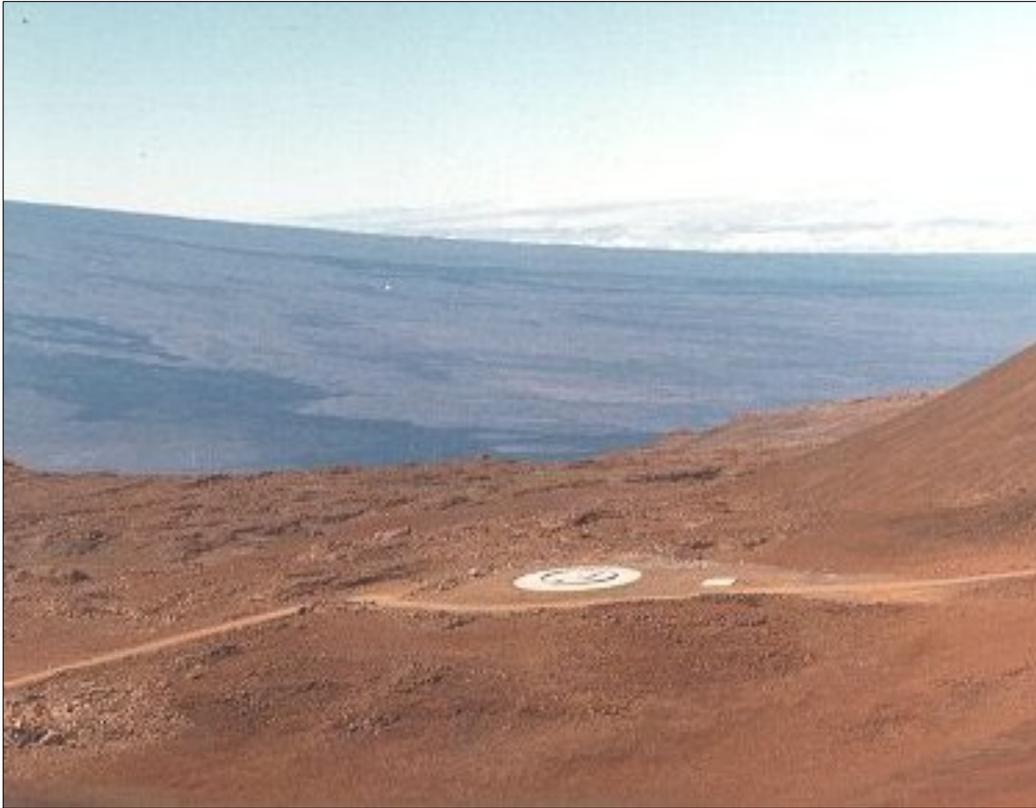
Figure 11. Observatory and outbuilding foundations in 1985, view to the southwest (Steiger 2009).
